Contract #: 04-0120F4Cty: SF/ALA Rte: 80 PM: 13.2/13.9File #: 69.28**WELDING INSPECTION REPORT****Resident Engineer:**Siegenthaler, Peter**Address:** 333 Burma Road**City:** Oakland, CA 94607**Report No:** WIR-020638**Date Inspected:** 16-Feb-2011**Project Name:** SAS Superstructure**OSM Arrival Time:** 1900**Prime Contractor:** American Bridge/Fluor Enterprises, a JV**OSM Departure Time:** 700**Contractor:** Zhenhua Port Machinery Company, Ltd (ZPMC), Changxing Island **Location:** Shanghai, China**CWI Name:** See Below**CWI Present:** Yes No**Inspected CWI report:** Yes No N/A**Rod Oven in Use:** Yes No N/A**Electrode to specification:** Yes No N/A**Weld Procedures Followed:** Yes No N/A**Qualified Welders:** Yes No N/A**Verified Joint Fit-up:** Yes No N/A**Approved Drawings:** Yes No N/A**Approved WPS:** Yes No N/A**Delayed / Cancelled:** Yes No N/A**Bridge No:** 34-0006**Component:** OBG**Summary of Items Observed:**

OBG Bay 14

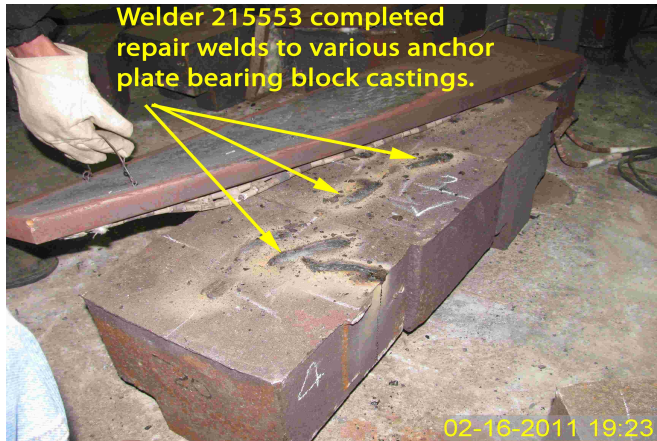
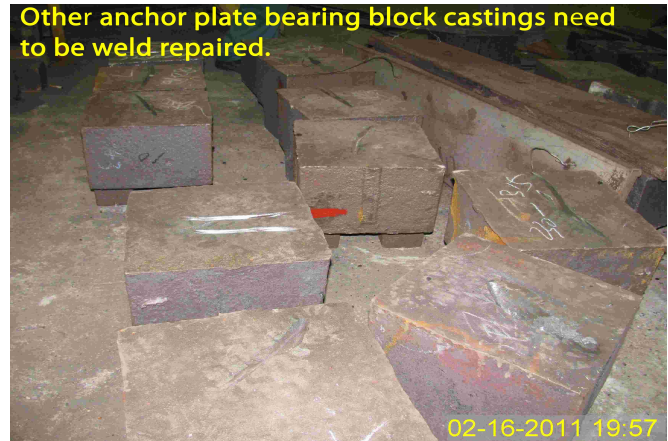
This QA Inspector observed ZPMC welder Mr. Yang Yunfeng, stencil 215553 used shielded metal arc welding procedure WPS-casting-SMAW-1G-Repair-1 to make a weld repair of visual rejections to OBG segment 14E anchor plate bearing block casting #087-1. ZPMC QC informed this QA Inspector that critical weld repair document B-CWR-2784 documents this weld repair. This QA Inspector measured a welding current of approximately 190 amps and Mr. Yang Yunfeng appeared to be certified to make this weld. Items observed on this date appeared to generally comply with applicable contract documents. See the photographs below for additional information.
